REHABILITATION PLAN FOR THE SPURGEON HOUSE

115 SOUTH COUNCIL STREET, MUNCIE, INDIANA

A 6-HOUR CREATIVE PROJECT

MASTER OF SCIENCE IN HISTORIC PRESERVATION

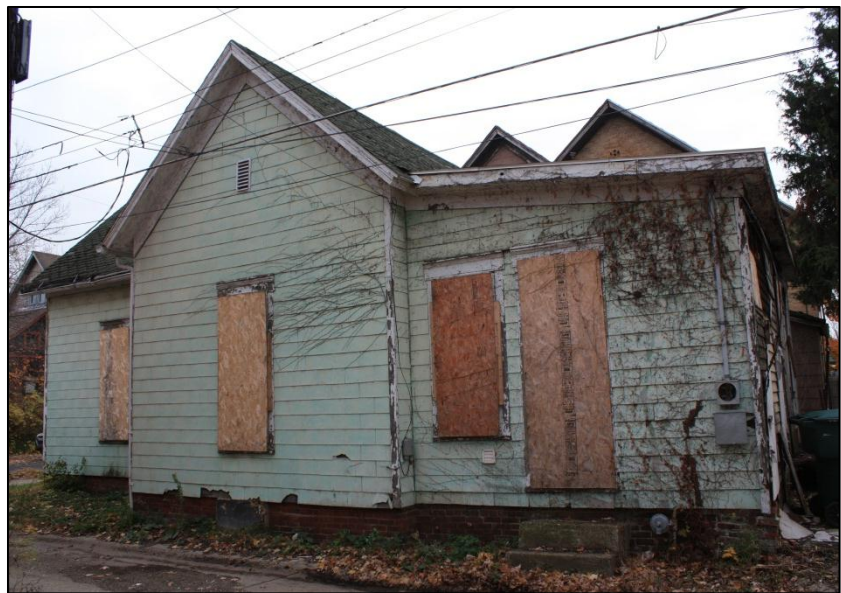
The north elevation has four bays (Figure 7) (035,

Figure 7: Photo of north elevation. Photograph by Emily Husted, 18 November 2010.

043, 044, 045). The east bay has a 4-over-4 double-hung wood window with wood trim, centrally located in the bay (042). The center bay has a 4-over-4 double-hung wood window with wood trim, centered in the gable end (041). A coal chute is located in the brick foundation under the window (037). A small air vent is located within the center of the gable end approximately 4 feet down from the ridge (041). The bay directly west of the center bay has a 1-over-1 double-hung wood window with wood trim (039, 040). The far west bay has an original glazed panel door with a single-light transom (039, 040).

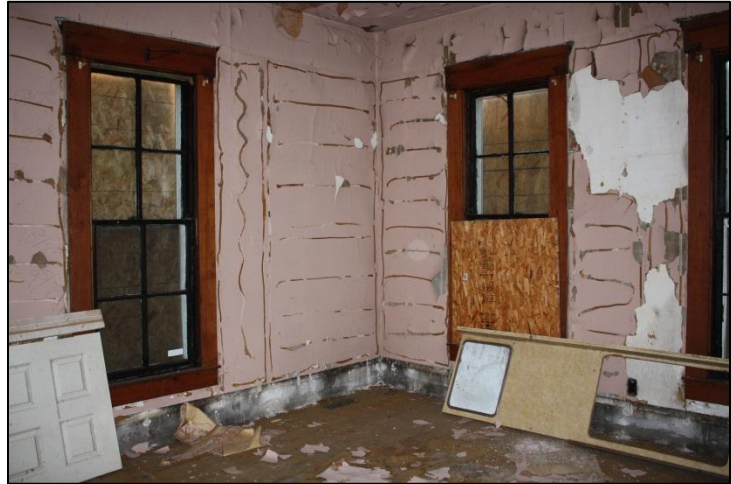
Figure 9: Photo of room 1 windows. Photograph by Emily Husted, 1 January 2012.

on the north and windows W2 and W3 on the east walls are surrounded with original, stained oak wood trim (Figure 9) (058). Plywood covers the bottom half of one of the windows on the east wall. All of the walls are plaster and lath. The non-original wood wall paneling that was removed left lines from the glue that was used to attach the panels to the wall (056, 057, 058, 059). A drop-ceiling had been installed, at an unknown date, but has since been removed by the current owners. The wood baseboards have been removed (056, 057, 058, 059, 060). The 6 inch wide tongue and groove pine wood floor remains throughout the home. The ceiling is plaster and lath (063). The room opens into room 2 on the west wall through an approximate 6 feet double-door opening with original, oak wood trim, though the double-doors do not remain (059, 065).

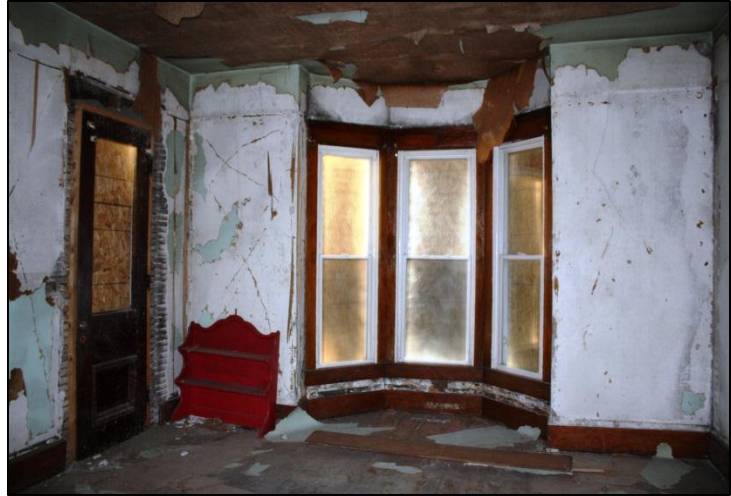
The exterior entrance into room 2 is from an original doorway, D2, located off the porch on the east wall of the interior room (Figure 10) (067). The wood trim surrounding the door has been

Figure 10: Photo of room 2 entrance and windows.
Photograph by Emily Husted, 18 October 2010.

removed, exposing the wood lath around the door. Windows W4, W5 and W6 of the bay window have original stained oak trim. All of the walls are plaster and lath (066, 068, 073). The original, oak wood baseboards remain on all walls (066, 068, 069, 070, 071, 073). The tongue and groove pine wood floor remains. The ceiling is plaster and lath (074).

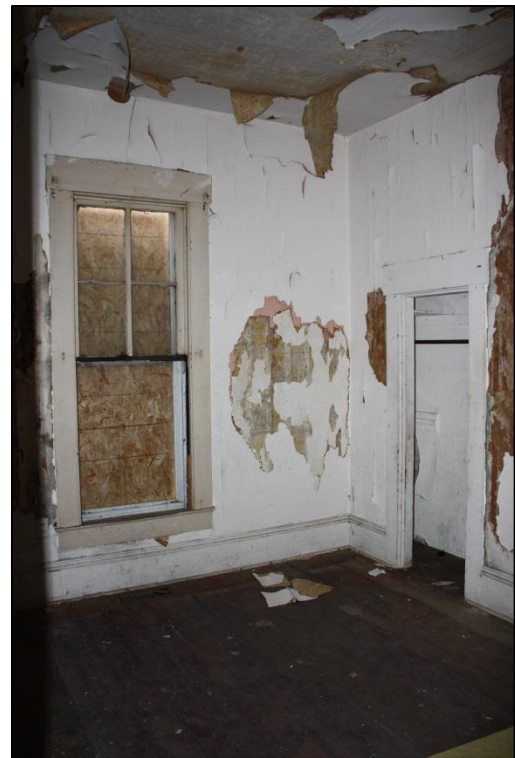
The entrance into room 3 is through an original door, D5, located on the south wall of the bedroom (Figure 11) (079). The door opening is surrounded by original oak wood trim and a single-light transom (091). The trim surrounding the door is stained on the dining room side (079) and painted on the bedroom

Figure 11: Photo of room 3. Photograph by Emily Husted, 1 January 2012.

side (087, 088). Window W11 on the north wall is missing the bottom sash and is surrounded with original, stained oak wood trim (089). A small opening with no door on the east wall leads into a small closet (085). All of the walls are plaster and lath. The painted oak wood baseboards remain (085, 088). The tongue and groove pine wood floor remains. The ceiling is plaster and lath (086).

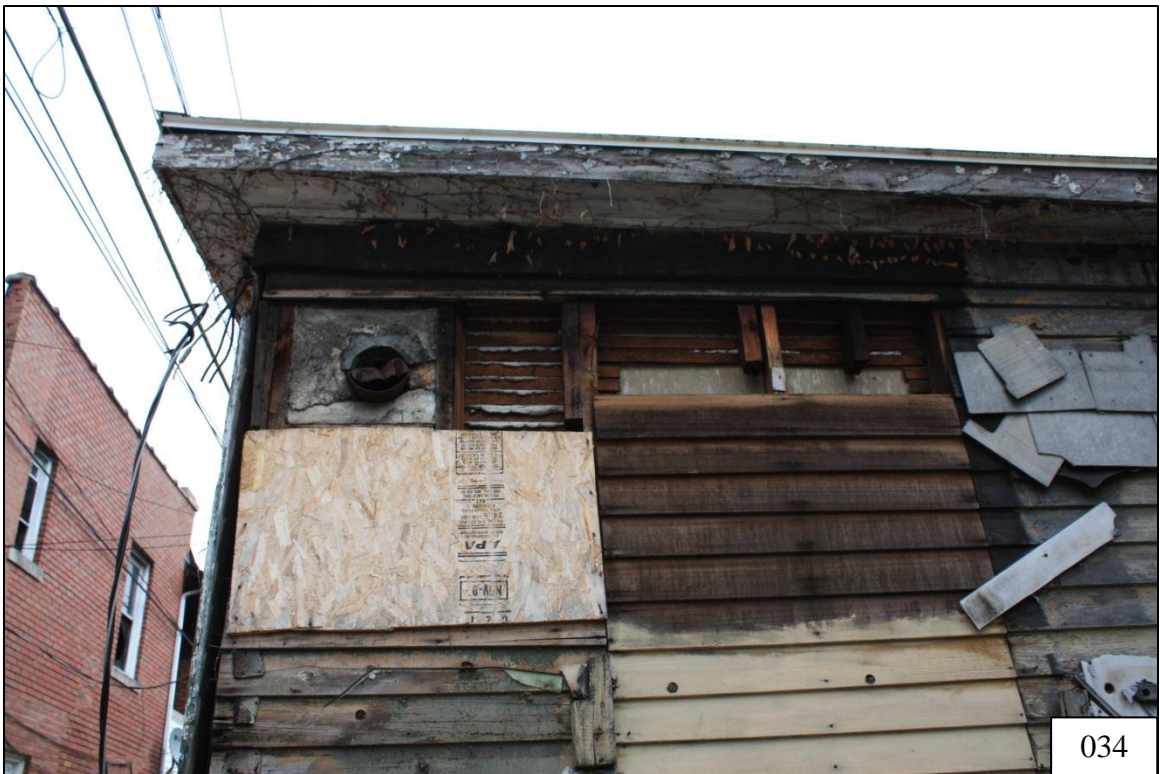
034

The west end of the home, however, shows significant signs of water damage. Approximately 20% of the ceiling has saturated and broken lath in the ceiling, which is sagging, indicating a roof leak (024, 034, 094, 109). Inspection of the attic space indicates a leak. The blown-in insulation is saturated with water over room 4 (153). The absence of approximately 22' of gutter on the west elevation has led to significant water damage of the fascia and eave boards (032, 033, 034). In addition to the roof repairs in this area, approximately 22' of new fascia and eave board to match the original will need to be installed, as well as a new gutter. Further inspection will be required to assess any damage that may have occurred to the entire west wall.

1. Further inspect the structural elements of the west elevation and make necessary repairs
2. Remove all trash and debris from room 6 and crawl space. Take inventory of all items and determine which pieces can be utilized in the rehabilitation or sent to an architectural salvage business. Dispose of all trash and donate unwanted items.

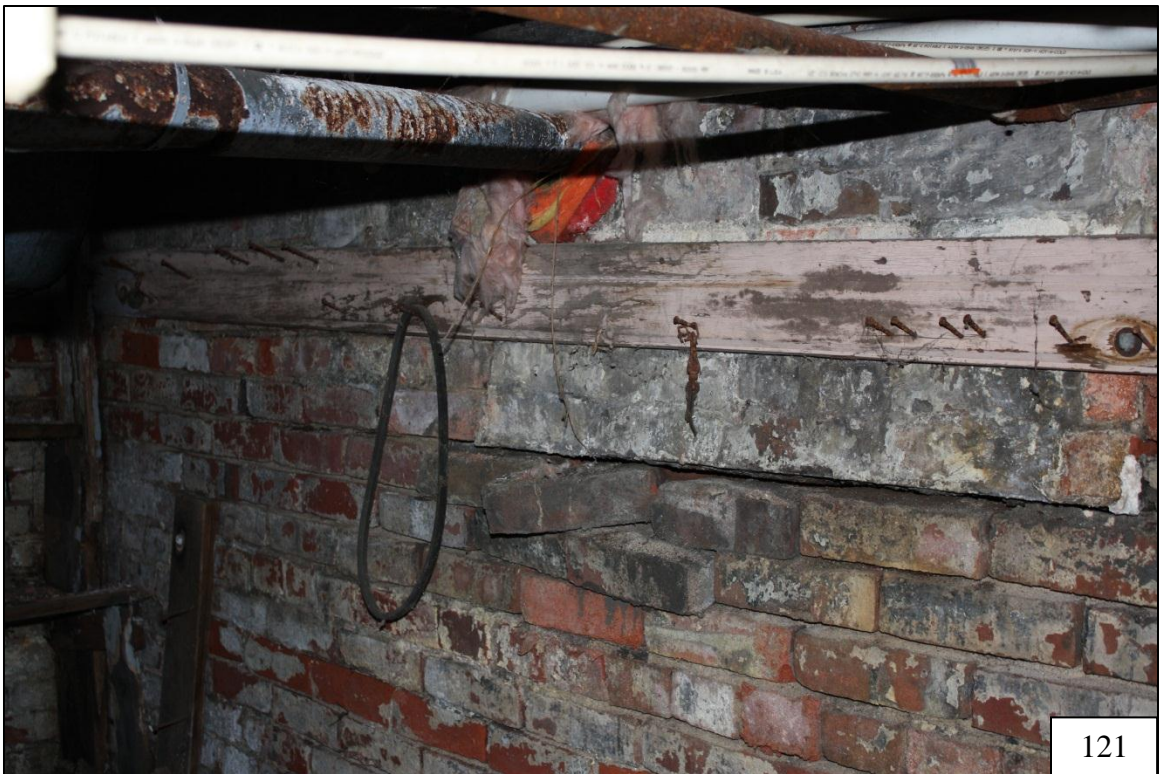
121

The foundation walls of room 6 are in fair condition, but approximately 50% of the south and west walls need to be repointed with type O mortar (121, 122).

6. Repair northwest foundation by reusing existing bricks and type O mortar.
7. Repoint 50% of the foundation in room 6 on the south and west wall.
8. If bricks need to be replaced, a number of original bricks remain loose in crawl space of room 6 (137).

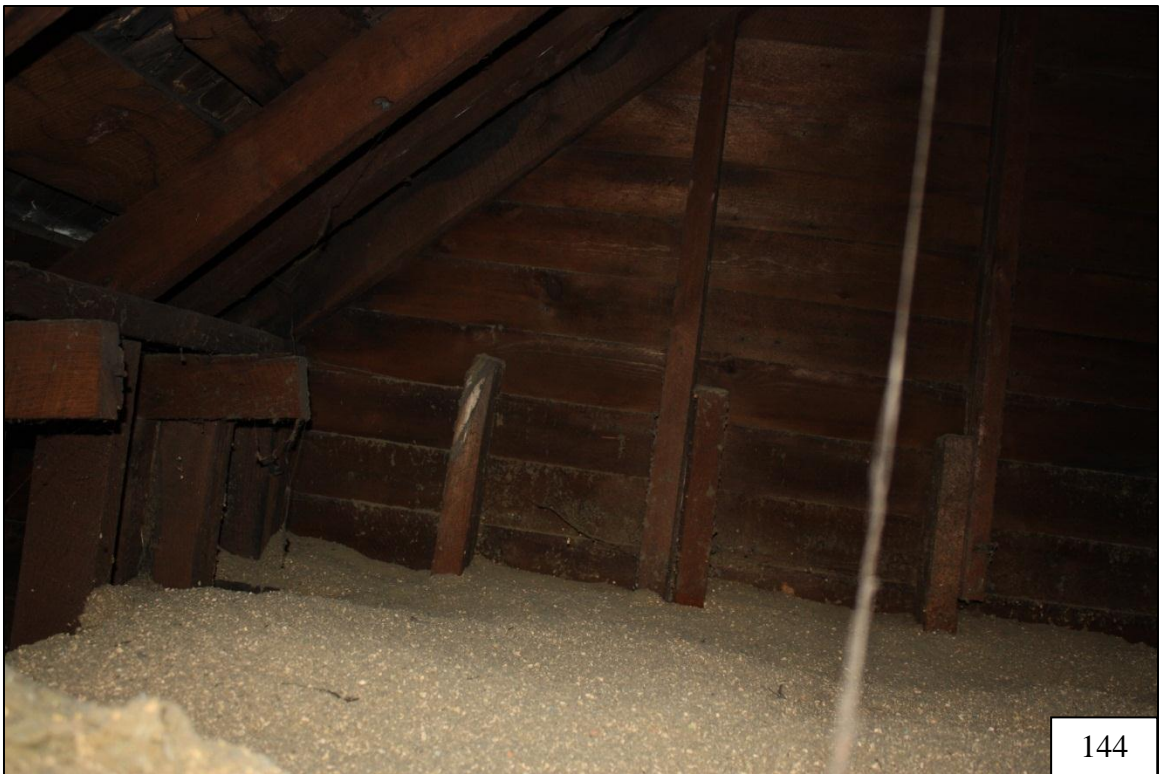
144

the south wall of room 6 has apparent termite damage (144). This damage has not compromised the wood, and there does not appear to be any active termites within the members.

5. Hire a professional exterminator to ensure the elimination of all termites.
6. Replace in kind the soleplate that was deteriorated by termites.
7. Fill damaged areas of joists with minimal termite damage with an epoxy wood filler and hardening product.

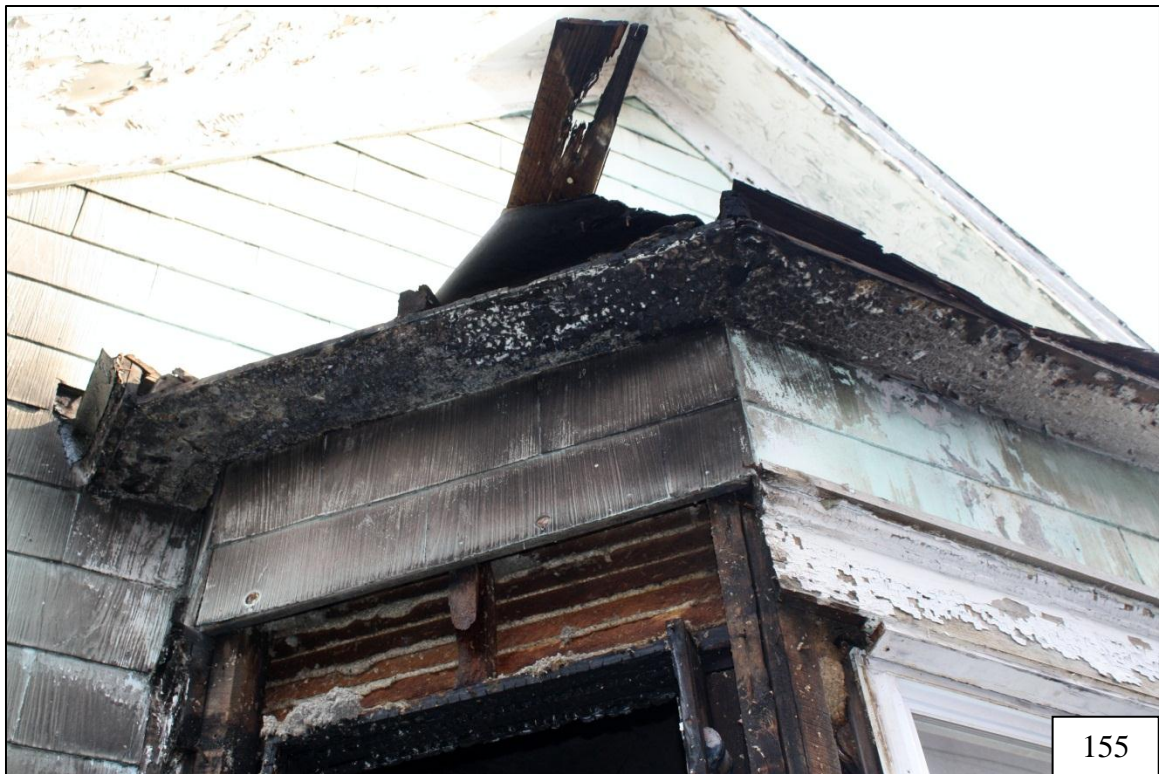
155

The roof above the bay window on the south wall shows signs of water damage and the fire in March 2012 caused some damage (155). Approximately 3' of fascia board is missing, leading to further water damage (016, 017, 018). The current roof material is

5. Remove asphalt sheeting from bay window. Inspect deck at eaves for wood deterioration and repair as required. Install new fascia board where missing-3 lf 1" x 3" poplar. Repair/secure existing fascia boards as required. Prime and paint with two coats good quality exterior semi-gloss acrylic latex paint. Replace damaged eave boards-7 lf 1" x 4" poplar. Prime and paint with two coats good
